Contract #: 04-0120F4Cty: SF/ALA Rte: 80 PM: 13.2/13.9File #: 69.28**WELDING INSPECTION REPORT****Resident Engineer:**Pursell, Gary**Address:** 333 Burma Road**City:** Oakland, CA 94607**Report No:** WIR-012551**Date Inspected:** 13-Feb-2010**Project Name:** SAS Superstructure**OSM Arrival Time:** 700**Prime Contractor:** American Bridge/Fluor Enterprises, a JV**OSM Departure Time:** 1900**Contractor:** Zhenhua Port Machinery Company, Ltd (ZPMC), Changxing Island **Location:** Shanghai, China**CWI Name:** Du Zhi Qun**CWI Present:** Yes No**Inspected CWI report:** Yes No N/A**Rod Oven in Use:** Yes No N/A**Electrode to specification:** Yes No N/A**Weld Procedures Followed:** Yes No N/A**Qualified Welders:** Yes No N/A**Verified Joint Fit-up:** Yes No N/A**Approved Drawings:** Yes No N/A**Approved WPS:** Yes No N/A**Delayed / Cancelled:** Yes No N/A**Bridge No:** 34-0006**Component:** Tower**Summary of Items Observed:**

WELDING INSPECTION REPORT

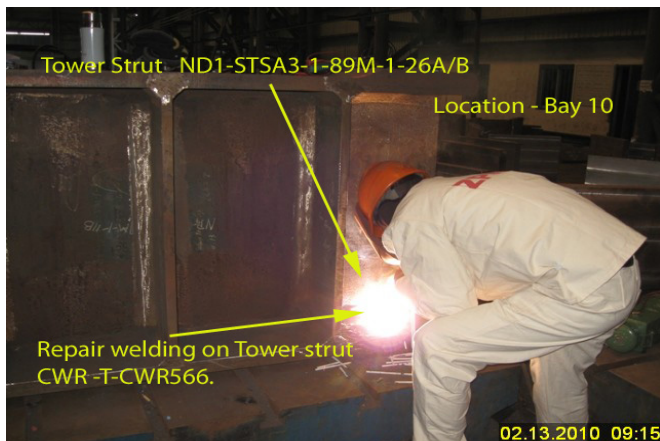
This QA Inspector observed ZPMC qualified welding personnel identified as 057258, Perform Shielded Metal Arc Welding (SMAW) on Tower Strut. The weld identified as ND1-STSA3-1-89M-1-26A/B. ZPMC QC Identified as Jiang La Mei, with Critical welding repair report, CWR-T-CWR566, The welding parameters as measured using QC's calibrated instrument appeared to be in general compliance with WPS-485-SMAW-2G (2F) - Repair. For

more information see attached photos.

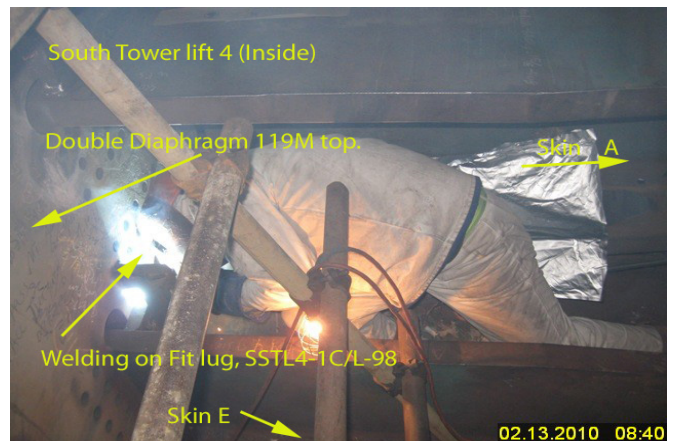
This QA Inspector observed ZPMC qualified welding personnel identified as 066733, Perform Flux Core Arc Welding (FCAW) on South tower lift 4 Fit Lug. The weld identified as SSSL4-1C/L-98, near double diaphragm 119M top. ZPMC CWI Identified as Gang liang Zhu, The welding parameters as measured using QC's calibrated instrument appeared to be in general compliance with WPS-B-T-4333-Tc-P4-F. For more information see attached photo.
